North Coast Regional Water Quality Control Board

Inspection Report for September 18, 2019 Warrant Inspection Humboldt County Assessor's Parcel Number 220-301-006-000

File: Cannabis Program Inspections, Humboldt County, September 2019
HCSO/Green Wave Humboldt County Inspections, Vicky Dillon, CIWQS Place ID
863221

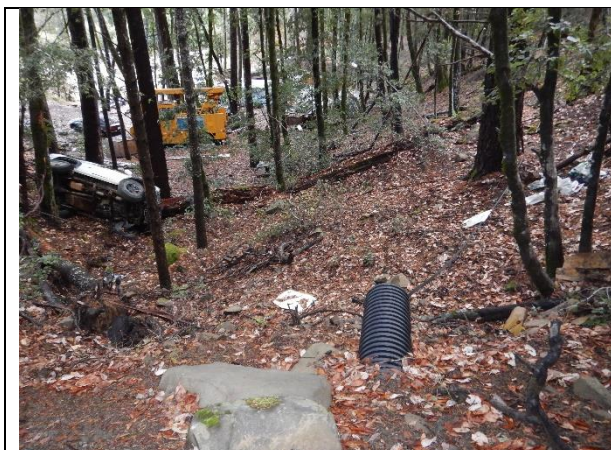
1. Site maintenance, erosion control and drainage features: At VD5 I observed a watercourse diverted down a road and into a pond.
2. Stream crossing maintenance and improvement: I observed three stream crossings. VD3 was shallowly placed, with a perched outlet and potentially undersized diameter. VD6 has a buried inlet and a perched, shot-gunned outlet with no clear channel downstream. The input channel to VD6 may have been VD5 prior to diversion. I observed a Humboldt crossing at VD9 that may be contributing to streambank erosion.

3. Riparian and wetland protection and management: I observed a water storage tank in the setback to a Class III watercourse at VD3. I observed domestic waste at the outlet of culvert VD6, which may be the historic channel of watercourse VD5.

11. Refuse and human waste: I observed an outhouse discharging to the ground at VD2, and domestic refuse in stream channels at VD3 and VD6.

Photo 7 – VD6; perched, shot-gunned culvert outlet into area with miscellaneous domestic waste

3. Remove waste from watercourses. Collect and dispose of or contain all refuse in a location and manner so as to minimize potential for these wastes to enter or be transported into receiving waters.

4. Retain a licensed professional to inventory, assess, and develop a workplan and schedule to correct:
 - a. Culverts VD3, VD6, and VD9 to minimize streambank and road fill erosion and to allow passage of 100-year flood flow including debris and sediment loads

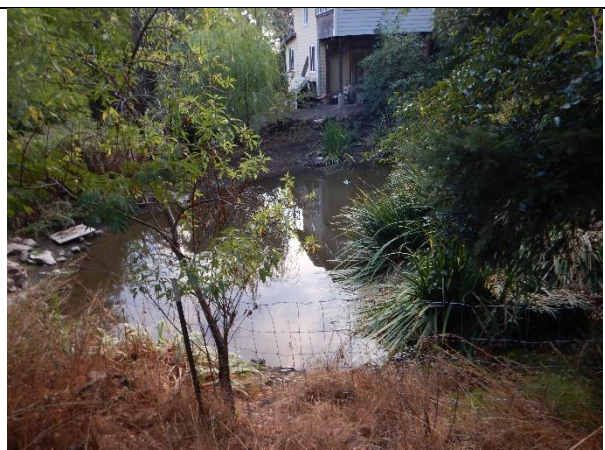
VD7	Pond	Small pond in front of house with 8" diameter overflow culvert in berm. Inflow from VD5	Water diversion and storage without regulatory coverage. Threatened discharge of waste to receiving waters.	8

Photo 8 – VD7; small pond in front of house

- b. Diverted stream VD5 to return the stream to its historic channel
 - c. Pond VD7 for erosion and/or stability issues
5. Work with the California Department of Fish and Wildlife (CDFW) and the State Water Resources Control Board's Division of Water Rights (DIV) to determine and secure any applicable permits or licensing required for surface water diversion,

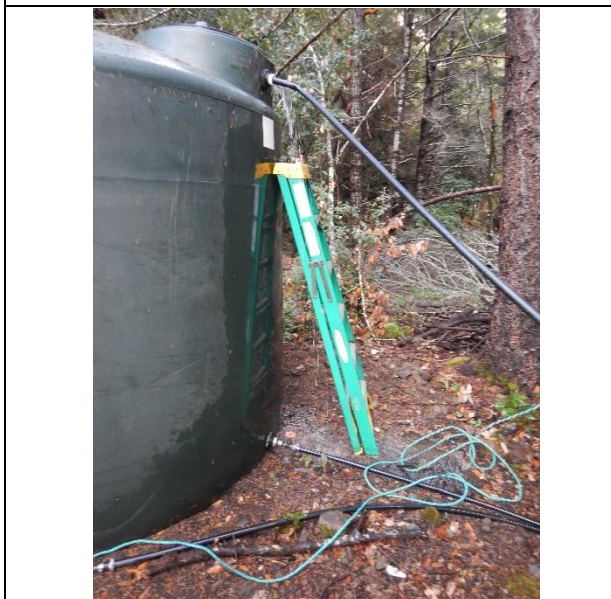
4. Spoils management: I did not observe water quality issues associated with spoils management.
5. Water storage and use: I observed an overflowing water storage tank at VD8. I observed two unpermitted diversion points in a stream at VD4. I observed a stream diverted down a road and into a pond at VD5.

Photo 9 – VD8; overflowing water storage tank

7. Install a float valve or similar device to shut off flow to water storage tank when the tank is full. Regularly inspect water diversion and storage infrastructure for overflow, leaks, and damage.

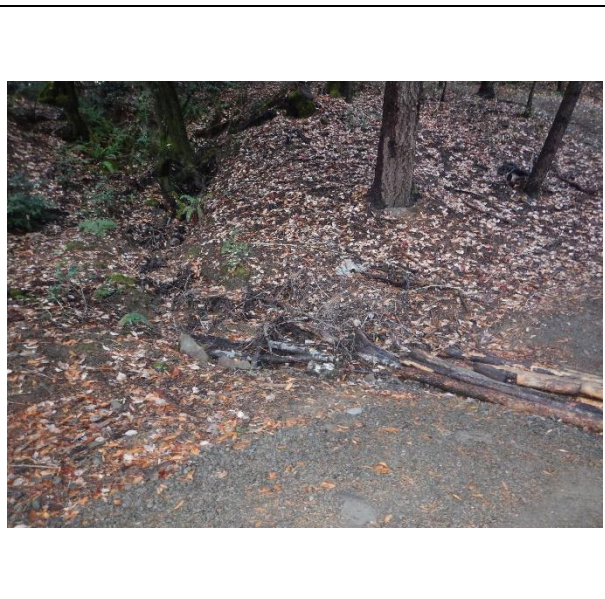
Photo 10 – VD9; Humboldt crossing on Class III watercourse

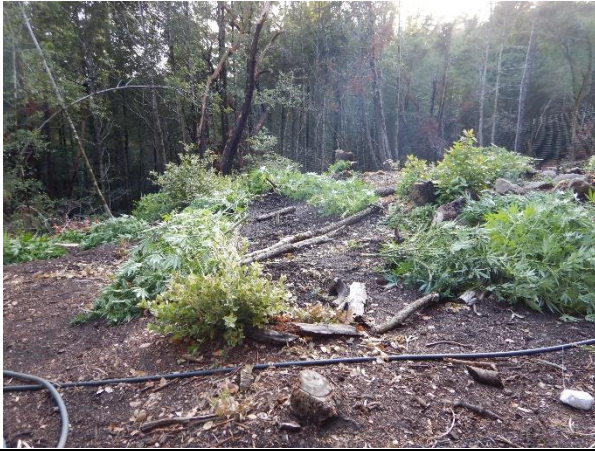
Photo 11 – VD10; outdoor cannabis cultivation

1. If the property owner and/or tenant(s) choose to continue to cultivate cannabis, enroll for coverage under and take steps to comply with the requirements of the CANGO (Order WQ 2019-0001-DWQ, General Waste Discharge Requirements and Waiver of Waste Discharge Requirements for Discharges of Waste Associated with Cannabis Cultivation Activities). Learn about the CANGO here:
